Home Built Airplanes & Vans Airforce Response

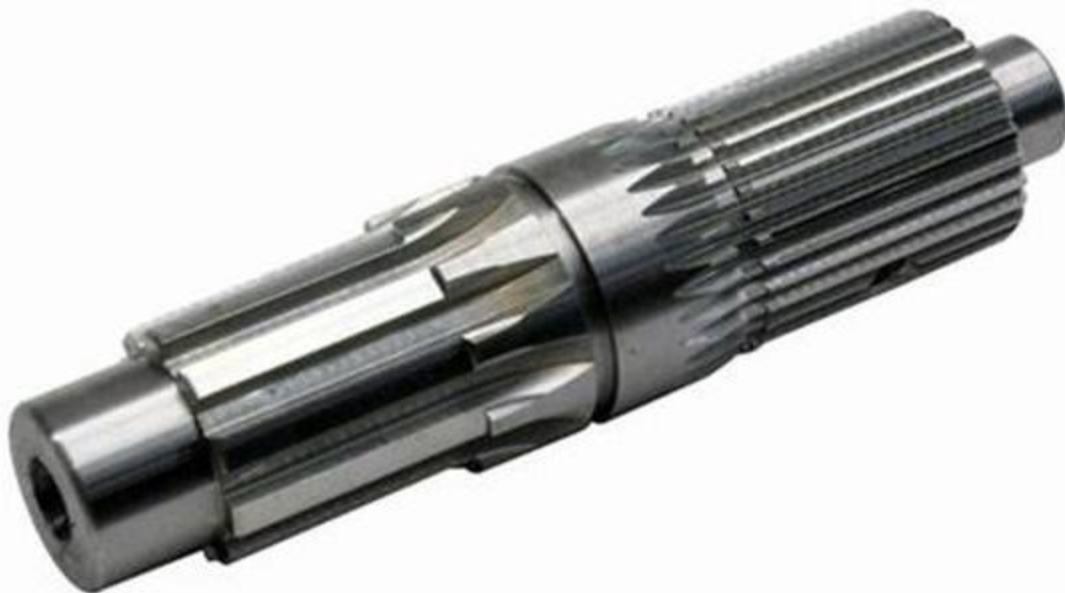
Regarding shaft design, both websites commented on proper design of shaft splines based on multi-spline automotive axle shafts which are a close comparison but not a 100% correlation, because it's the wrong shaft. The attached picture is one of the shafts from a quick change differential that uses these gears designed and machined the same way. It takes a lot more abuse in its racing application with high horsepower and maximum torque at the rear axle plus impact loads fed back from the road, tires, and suspension.

The existing shaft design has proven to be very tough. If it wasn't it would not have continued for so many flights for Andreas after being damaged. However, no shaft design will tolerate excessive bending under excessive loads if the case or housing that supports it flexes too much. Even upgraded axle shafts are usually not installed in stock rear axle housings. By piecing together the limited information from the three gearboxes with this shaft failure this is what I believe happened all three times with the cast aluminum case when pushed beyond its' limits. Of course being able to inspect Andreas' gearbox would help a lot, even if it has been overly exposed to too many hands. The evidence that we do have indicates that the excessive combination of loads under these conditions causes the nose of the cast case to flex downward eliminating the gear lash clearances between the gears causing the gears to bind against each other. This puts the propeller shaft in bending at the gear concentrating this NEW load into the smallest cross section of the shaft aft of the gear. Under the combination of excessive power, torque, high G's, extreme gyroscopic loads from the propeller, and this new load into the shaft during this maneuver makes the overall condition so bad the shaft has no choice about breaking. Remember, all of this is caused by miss use and abuse beyond the design limitations. If the shaft were a lot stronger those loads would only move on to somewhere else and cause something else to fail. This is always the case when the issue is the miss use and abuse of anything. In this situation it's not just how high the G's are, it's the excessive horsepower and torque that was added on top of the high G's.
