# BW350 Clutch Maintenance

## Pilot Bushing and Clutch Disk Inspections

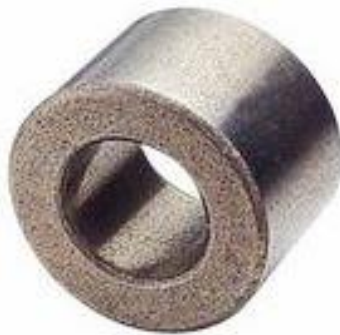
Dorman part# 14650

This is a picture of a brand new pilot bushing that is commonly used in all LS V8 standard transmission installations, and the one used with all the BS350 installations.

The first one has a smooth bore and the second one has what is called a fingered bore with slots intended for holding grease. There are pro and con theories on which is better, but the most common one are the smooth bore. Both are "self" lubricating.

Things to check for are excessive wear (ID is 0.60" new), out of round, scouring, etc.

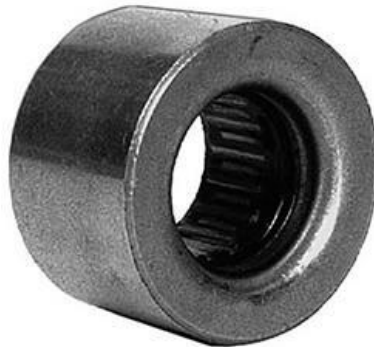
Chevy part# 14061685

Another option is the needle bearing version below.

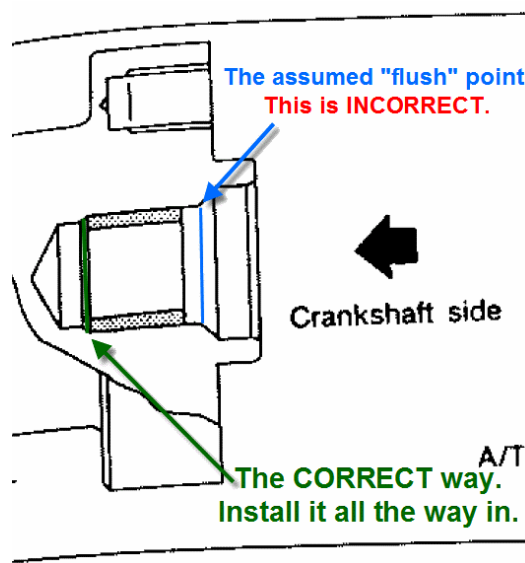
There is considerable debate on the subject of bushing versus bearing, and both camps will swear that theirs is hands down better because the other one failed on them. Whichever camp you decide to go with the most important thing is the correct installation shown below. Getting this wrong the first time is probably what convinced members of each camp to go the other way.

All of these bearings should be greased with any good grade of axle grease. A thin layer is sufficient as excess grease could easily sling out on the flywheel and clutch disk.

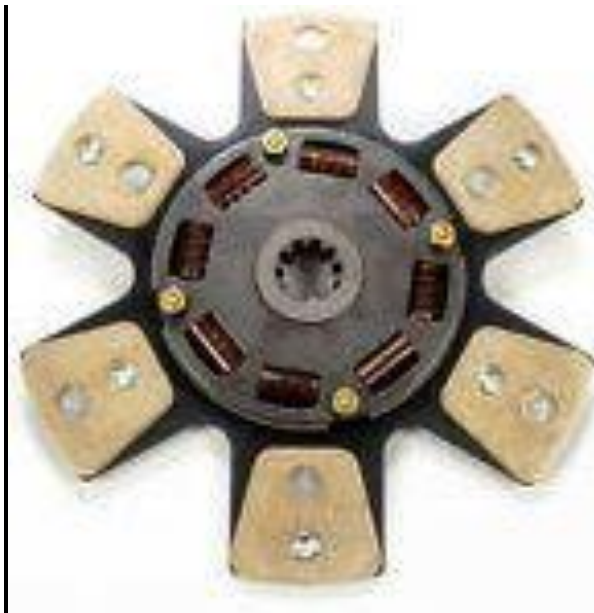
New

This bearing is what supports the end of the input shaft and keeps it centered with the engine crankshaft. If the bushing wears out too much the clutch disk will be off center forcing the damping hub to compensate. It will last for a while, but eventually the hub is forced to fail as in the picture below. This can also do damage to the input shaft bearings in the gearbox.

Ram Clutch part# 6121

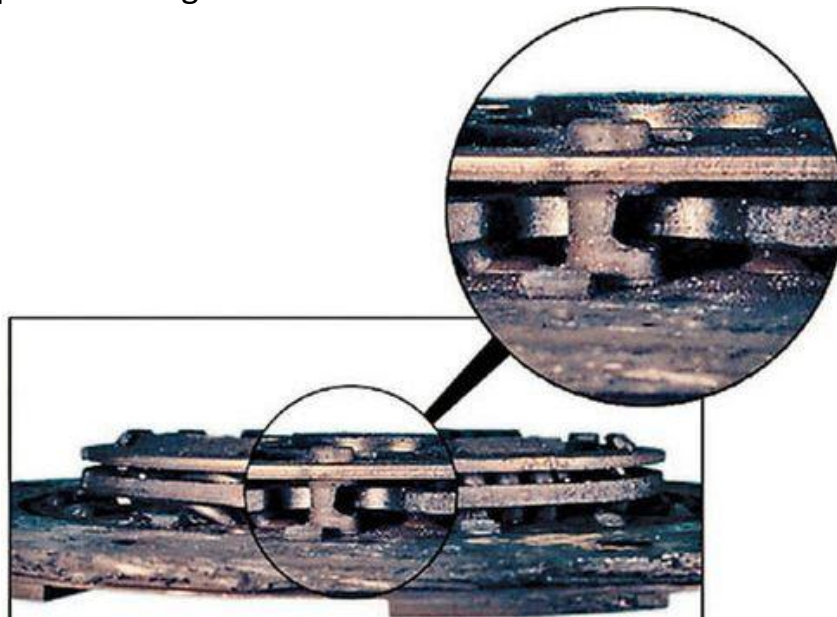
If you see any damage to the pilot bushing check the clutch disk for any signs of unusual wear, burning, or glazing on the friction surface.

In the hub pay particular attention to the bolts that hold the hub together and for signs that the hub stops are damaged.

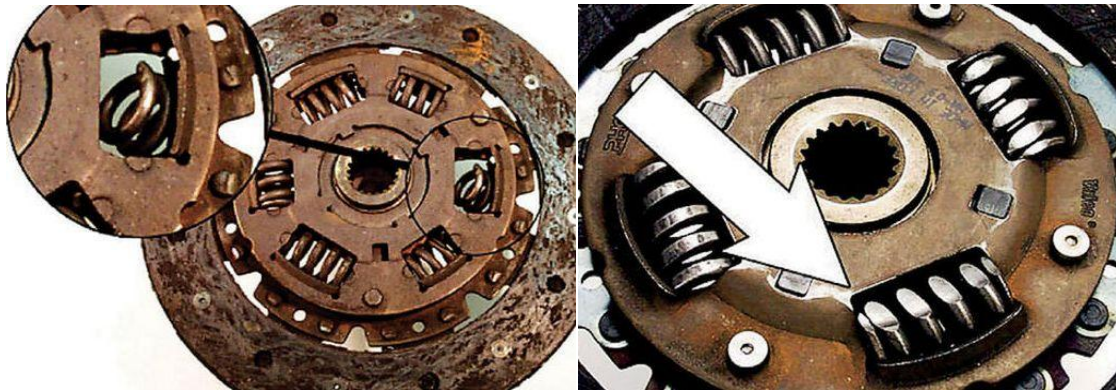
The springs should be secure in their pockets without any signs of wear.

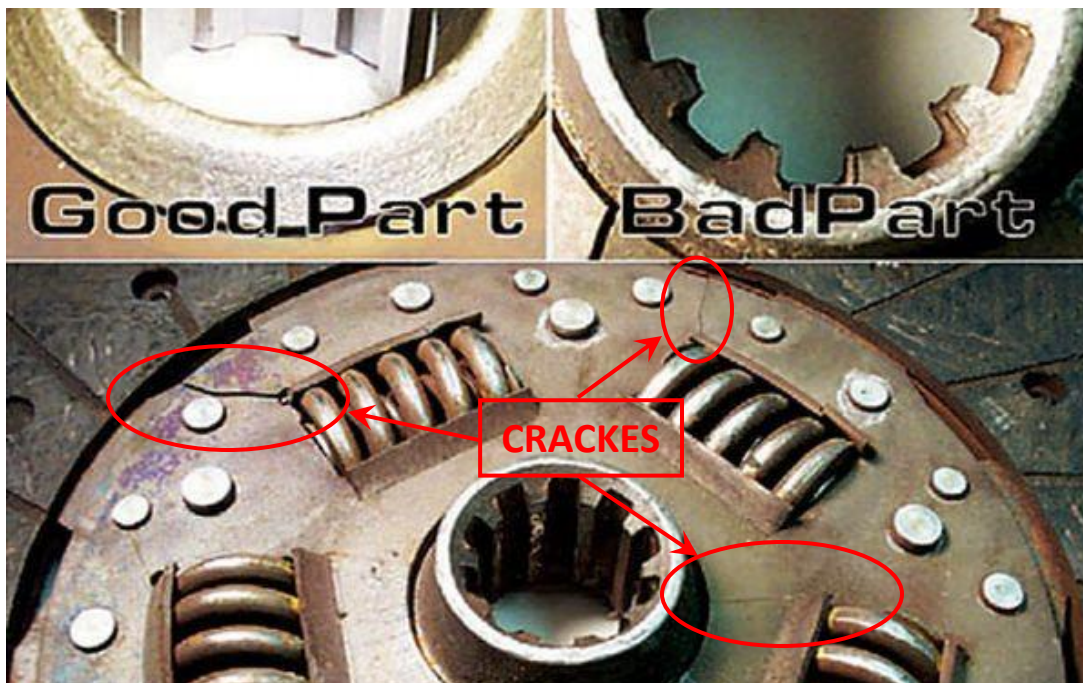
Check the splines for any wear like below. The front and back plates of the hub should be checked for any signs of cracking too.

If the bushing or clutch disk shows any signs of wear or damage immediate replacement is required! If the flywheel or pressure plate has issues get them serviced. Don't risk your safety by flying with parts worn beyond limits.
